# Manhole Inspection Summary

Manhole # S23II1026MH

Insp Date: **11/22/06 9:29 AM**

**Location** Address: **4220 ROLAND HEIGHTS AVE** Cross Street: **NEWPORT AVE**

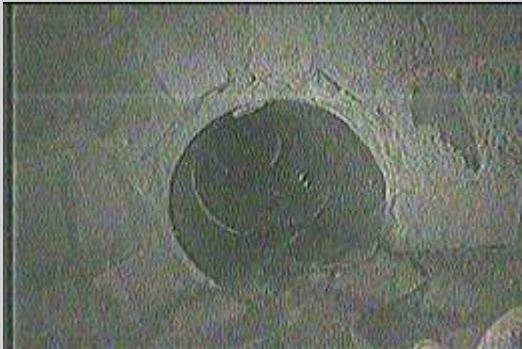
### 8 in. Circular Gravity Sewer Pipe Out @ 12 O'Clock

Pipe Material: **Clay** ☐ Pipe Lined

Invert Depth: **11.75** (ft.) Flow Characteristics: **Fast**

Infiltration: **None** Pipe Seal Cond: **Unknown**

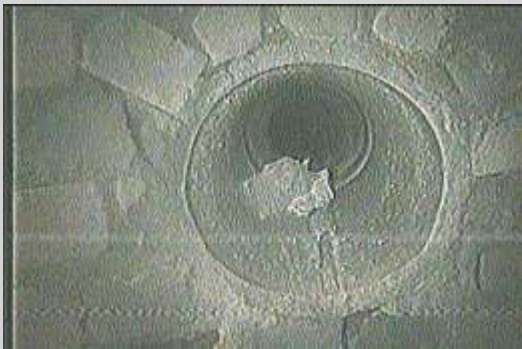
### 8 in. Circular Gravity Sewer Pipe In @ 3 O'Clock

Pipe Material: **Clay** ☐ Pipe Lined

Invert Depth: **9.33** (ft.) Flow Characteristics: **Fast**

Infiltration: **None** Pipe Seal Cond: **Unknown**

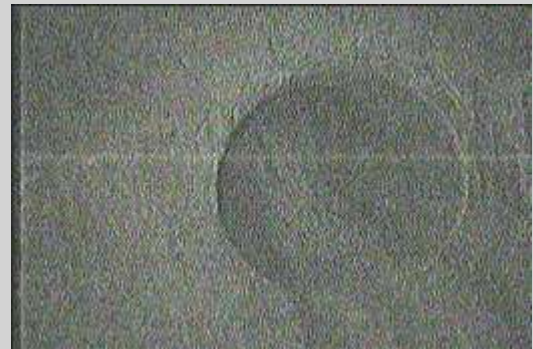
### Drop In @ 3 O'Clock

Drop: **Outside** Rod and Bar

Angled: **Yes** Reading: **10.50** (ft.)

Drop Condition: **Open**
